# SERVICE NOTE FOR ACCESSORY UNIT DRIVES WITH 1.9 TDI ENGINES WITHOUT AN OVERRUNNING ALTERNATOR PULLEY

TECHNICAL INFO NO.1015

1.9 TDI

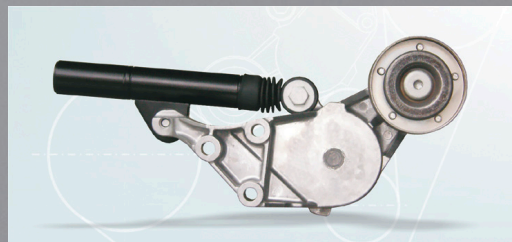
Figure 1: Tensioning unit 55714 - used in 1.9 TDI engines

In the worst case, excessive dynamic movement of the poly V-belt can lead to noise build-up, or even damage to the poly V-belt tensioner.

This leads to a failure of the complete assembly drive, which causes the vehicle to break down.

In assembly drives with the tensioning unit 55714 (Figure 1), the rigid belt pulley on the alternator must be replaced with a RUVILLE overrunning alternator pulley (Figure 2). If an overrunning alternator pulley has already been fitted, this must be checked to ensure it is operating correctly.

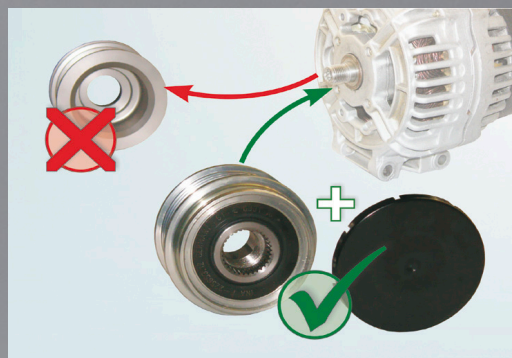
Figure 2: Replacing the overrunning alternator pulley

The use of an overrunning alternator pulley considerably relieves the pressure on all components within the assembly drive.
