# NOISES FROM FRONT END ACCESSORY UNIT DRIVE AREA ON 1.9 TDI ENGINES

TECHNICAL INFO NO. 1022

1.9 TDI

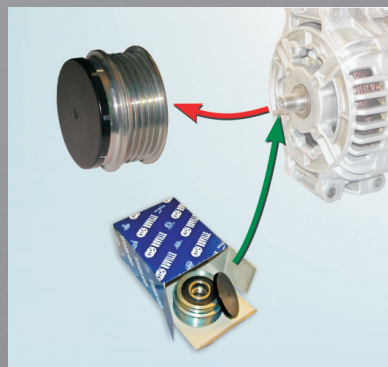
Image 1: Recommendation: Replace the overrunning alternator pulley

If the V-ribbed belt is subjected to strong, dynamic movement, this may cause the engine to produce loud noises.

In some cases, the noise continues even after the V-ribbed belt and the tensioner and deflection pulleys have been replaced.

**The recommended repair is to replace the overrunning alternator pulley.**

This considerably relieves the pressure on the assembly drive by reducing both the tension peaks on the belt and the vibration behaviour.

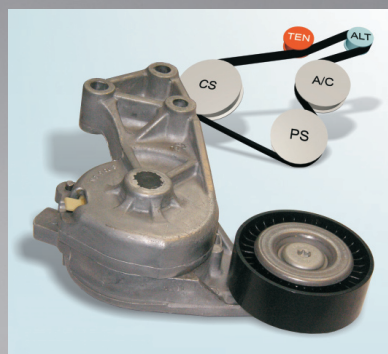
Bild 2: Tensioner lever 55716 installed in 1.9 TDI engines with belt path
