VIBRATION DAMPER FAILURE AT THE GENERATOR

TECHNICAL INFO NO. 1957

Nissan:	Almera, Micra
Renault:	Clio II + III, Scénic, Grand Scénic, Kangoo, Mégane II

Nissan	1.5 DCI (1/2002→)
Renault:	1.5 DCI (2003→)

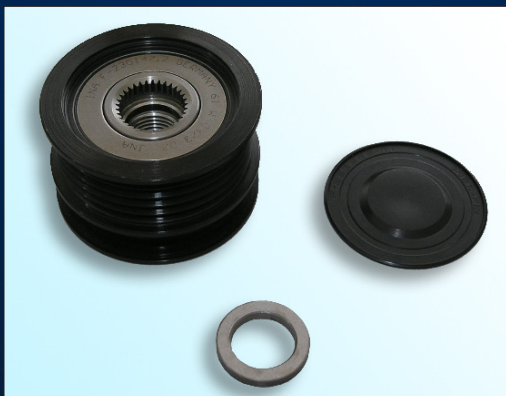
Picture 1: Overrunning alternator pulley 56334

Vibration damper failure can cause subsequent vehicle breakdown! Adhere to the manufacturer's specifications at all times!

On a defective vibration damper the rubber has come loose from the metal parts resulting in the loss of the damping function.

Alternatively, RUVILLE offers an overrunning alternator pulley (56334).

In response to their repeated failure during operation, we recommend that the original equipment vibration dampers be inspected, and replaced if necessary, whenever the car is serviced.
