Installation instruction when changing the wheel bearing / drive shaft joint

Technical Info No. 1757

Volvo

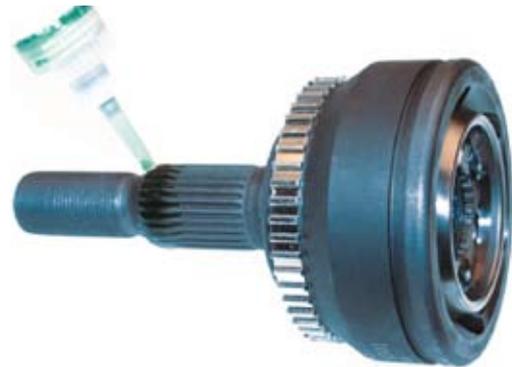
Vibrations and cracking noises after installing a wheel bearing or changing the drive shaft joint.

After the drive shaft joint has been reinstalled, minimal play remains between the wheel bearing/drive shaft joint splines.

This may under certain circumstances give rise to the above-mentioned problems in the vehicles specified.

Apply a 3-4 mm wide bead (Volvo metal adhesive, part no. 1161370) around the outer edge of the splines.
