Checking the tensioning and deflecting pulleys during the inspection

Audi, Seat, Skoda, Volkswagen

Engine: 1.4; 1.4 16V
1.6; 1.6 16V

INA 0003

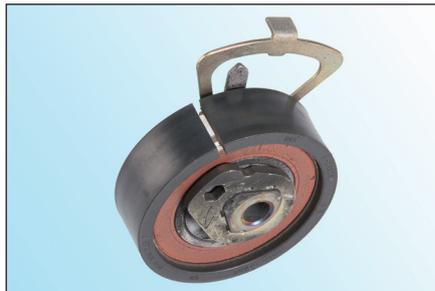
Fig. 1

With reference to several models produced by the manufacturers named above with 8 V and 16 V engines, in a few instances the toothed belt tensioning pulley (**fig. 1**) and/or the toothed belt deflecting pulley (**fig. 2**) may show evidence of damage in the area of the pulley running surface.

Damage to the pulley running surface may, under some circumstances, lead to damage to the toothed belt and, subsequently, to breaking of the toothed belt.

We recommend that all belt drive components are visually inspected at 30,000 km or, at the very latest, at 60,000 km.

Should you discover damage to the pulley running surfaces, replace the damaged components.

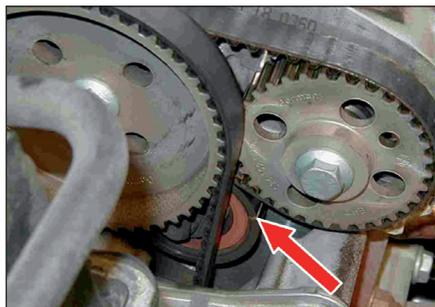
Fig. 3

Turn the engine slowly by hand as damage to the pulley running surface (**fig. 3, arrow**) may be located on the underside where it cannot be seen. The engine should be rotated several times to ensure the entire diameter has been checked.
