FAG Service Info

Installation instructions – Renault Laguna II

Correct installation of rear hub carrier bush

Models: Laguna II
Laguna II Grandtour

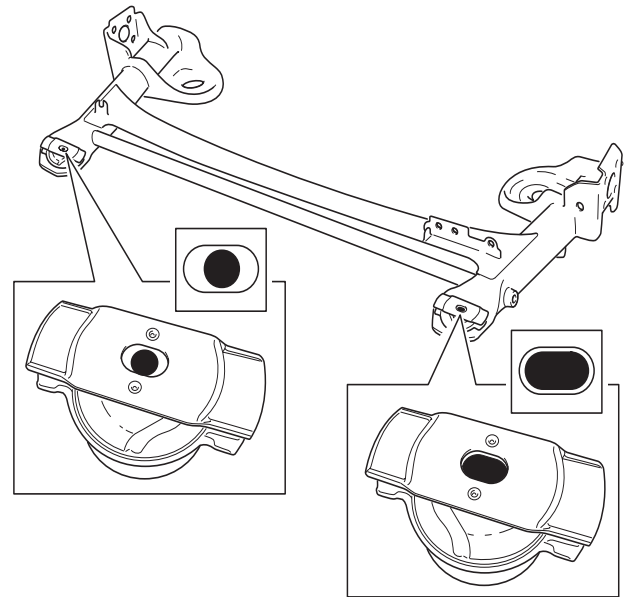
Fig. 1: Correct orientation of carrier bushes in the rear axle beam

Nr.	OE-numbers	FAG	Name
1	8200427869	829 049 410	Rear hub carrier bush (round hole)
2	8200427868	829 049 310	Rear hub carrier bush (elongated hole)
1+2	7701209534	830 003 630	Rear hub carrier bushes (pair)

The repair set 830 003 630 comprises two different rear hub carrier bushes (829 049 410 and 829 049 310), which absolutely must be installed according to OE specifications. So please observe Figure 1, which shows the correct installation position and orientation of the components. When repairing the hub carrier bushes they should always be replaced as a pair.
