# ARTICLE INFORMATION ON OVERRUNNING ALTERNATOR PULLEY 55627

TECHNICAL INFO NO. 1005

Dacia, Renault

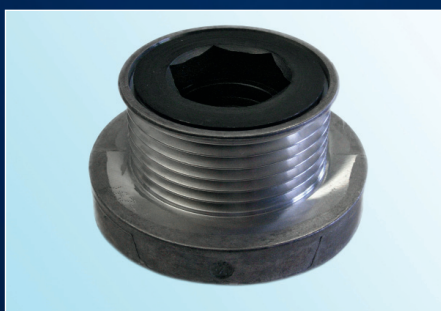
Fig. 1: Alternator Belt Pulley 77 00 110 616

Should the alternator belt pulley be defective (OE ref. 77 00 110 616), it is to be replaced by an overrunning alternator pulley. The overrunning alternator pulley is available with RUVILLE No. 55627.

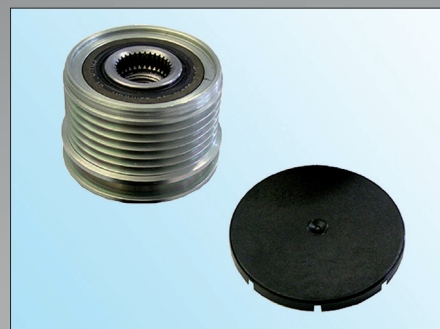
Fig. 2: Overrunning Alternator Pulley RUVILLE 55627

1 x overrunning alternator pulley  
1 x sealing cap

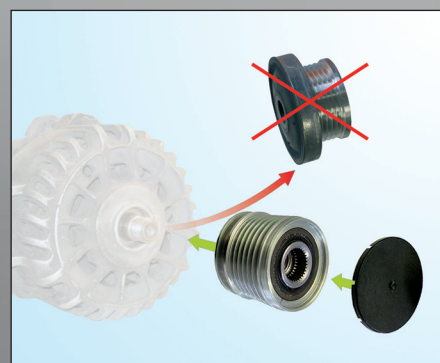
Fig. 3: Replacement procedure

1. Slacken tensioner and remove poly V-Belt
2. Check all belt drive components for damage  
- replace damaged components
3. Remove the original belt pulley from the alternator (see Fig. 3)
4. Assemble the Overrunning Alternator 55627 with the relevant special tool.
5. Assemble the seal cap on the Overrunning Alternator Pulley  
- Ensuring it is seated correctly and is a tight fit!
6. Assemble the poly V-Belt
