REPAIR SOLUTION FOR THE OPEL WATER PUMP

TECHNICAL INFO NO. 1045

Opel | Agila 1.0, Astra G 1.2, Astra H 1.4, Combo, Corsa C
Corsa D, Meriva, Tigra

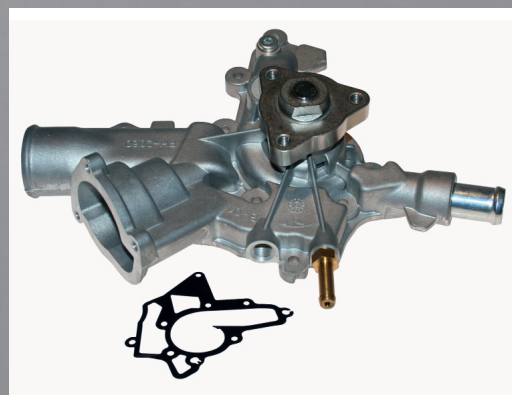
Fig. 1: 65381 (without temperature sensor)

1. "Small" repair solution (Article No.: 65381)

Pump without temperature sensor

We recommend the small repair solution if the temperature sensor can be dismantled and is technically in order.

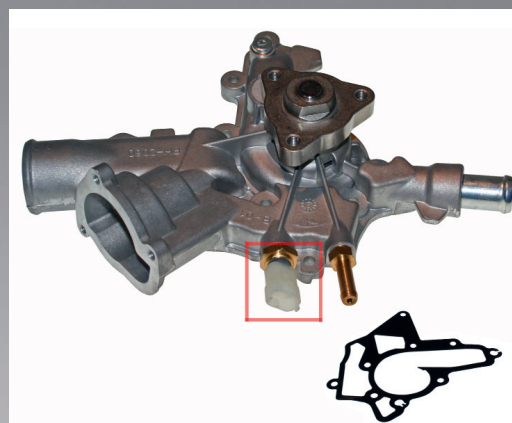
Fig. 2: 65384 (with temperature sensor)

2. "Large" repair solution (Article No.: 65384)

Pump with temperature sensor

We recommend the large repair solution when the abovementioned points do not apply.
