MERCEDES WATER PUMP WITH 2 THERMOSTATS

TECHNICAL INFO NO. 1054

Mercedes	Actros 1831, 2031 Actros MP2 / MP3, without retarder MK 1417, 1717, 814, 817
-----------------	--

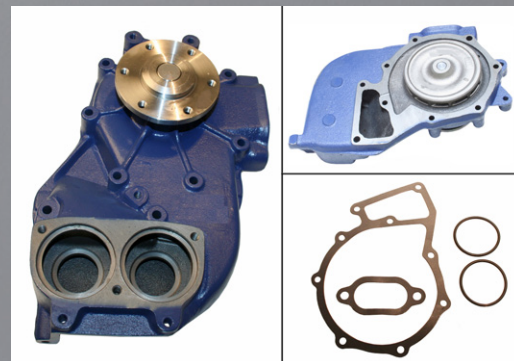
1. „Small“ repair solution (Article No. 65135)

without thermostats

Figure 1: Water pump 65135 (without thermostats)

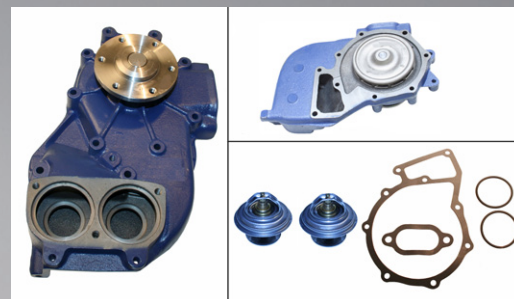
2. „Large“ repair solution (Article No.: 65135S)

with 2 thermostats (83°C)

Figure 2: Water pump 65135S (with thermostats)

With immediate effect, Ruville now offers an additional repair solution for the stated applications. The repair solution includes not only the water pump with the four necessary seals but also both thermostats (83 °C).
