CIRCLIPS MADE OF POLYAMIDE FOR AXIAL JOINTS

TECHNICAL INFORMATION NO.: 1095

Renault	Clio II+III, Kangoo
Nissan	Kubistar, Mikra (...K12)

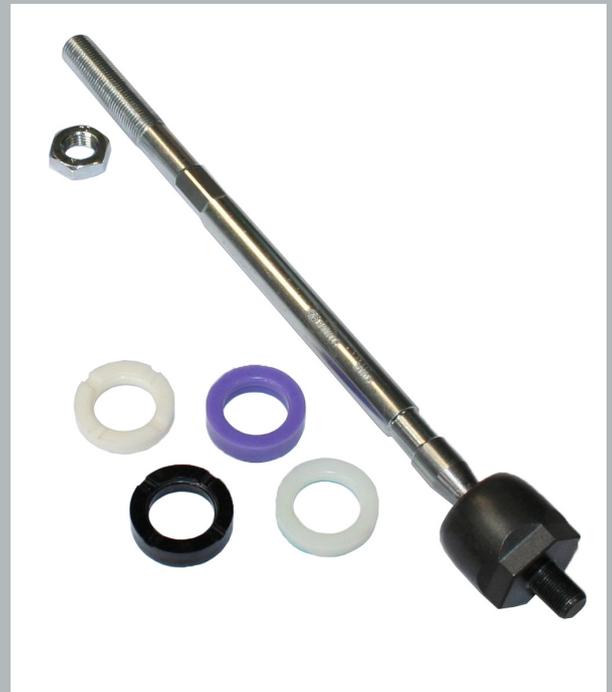
Fig. 1: Axial joint and circlips 915597

Some models by Renault and Nissan are fitted with an OE circlip consisting of a polyamide ring to retain the axial joint. The polyamide ring gets squashed during installation and therefore always has to be replaced every time it is removed.

The circlips are allocated correctly according to the colour of the removed ring.

- Replace the circlip every time after it has been removed.
- Allocation according to the colour of the ring

Furthermore, replacement of the circlip is a mandatory OE requirement.

As your service partner, RUVILLE therefore includes all corresponding polyamide rings with the respective axial joints.
